MANAGING RISKS FROM LIGHTNING STRIKES TO AIRCRAFT

Bruce D. Fisher
NASA Langley Research Center
Hampton, VA 23665

Presented at Flight Safety Foundation Fortieth
International Air Safety Seminar

ABSTRACT

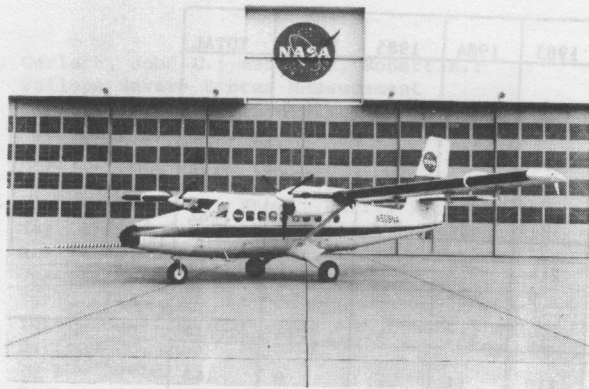
Figure 1.- NASA Langley Research Center DHC-6 Storm Hazards research airplane used in 1978.

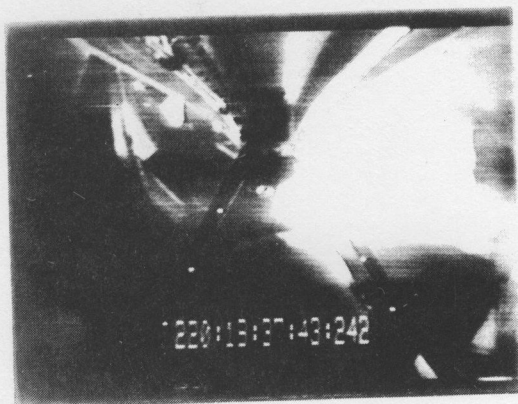
(a) 19:37:43.208 GMT.

(b) 19:37:43.242 GMT.

Figure 14.- Photographs from cockpit-mounted, forward-facing video camera of strike 13 of 1986. Refer to figure 13.
